Re: *HPH and Tank 1010 Pore Water Characterization Report*
Bayer CropScience Institute Facility, Institute, West Virginia

**HPH and Tank 1010
Pore Water Characterization Report
Bayer CropScience Facility
Institute, West Virginia**

October 2013

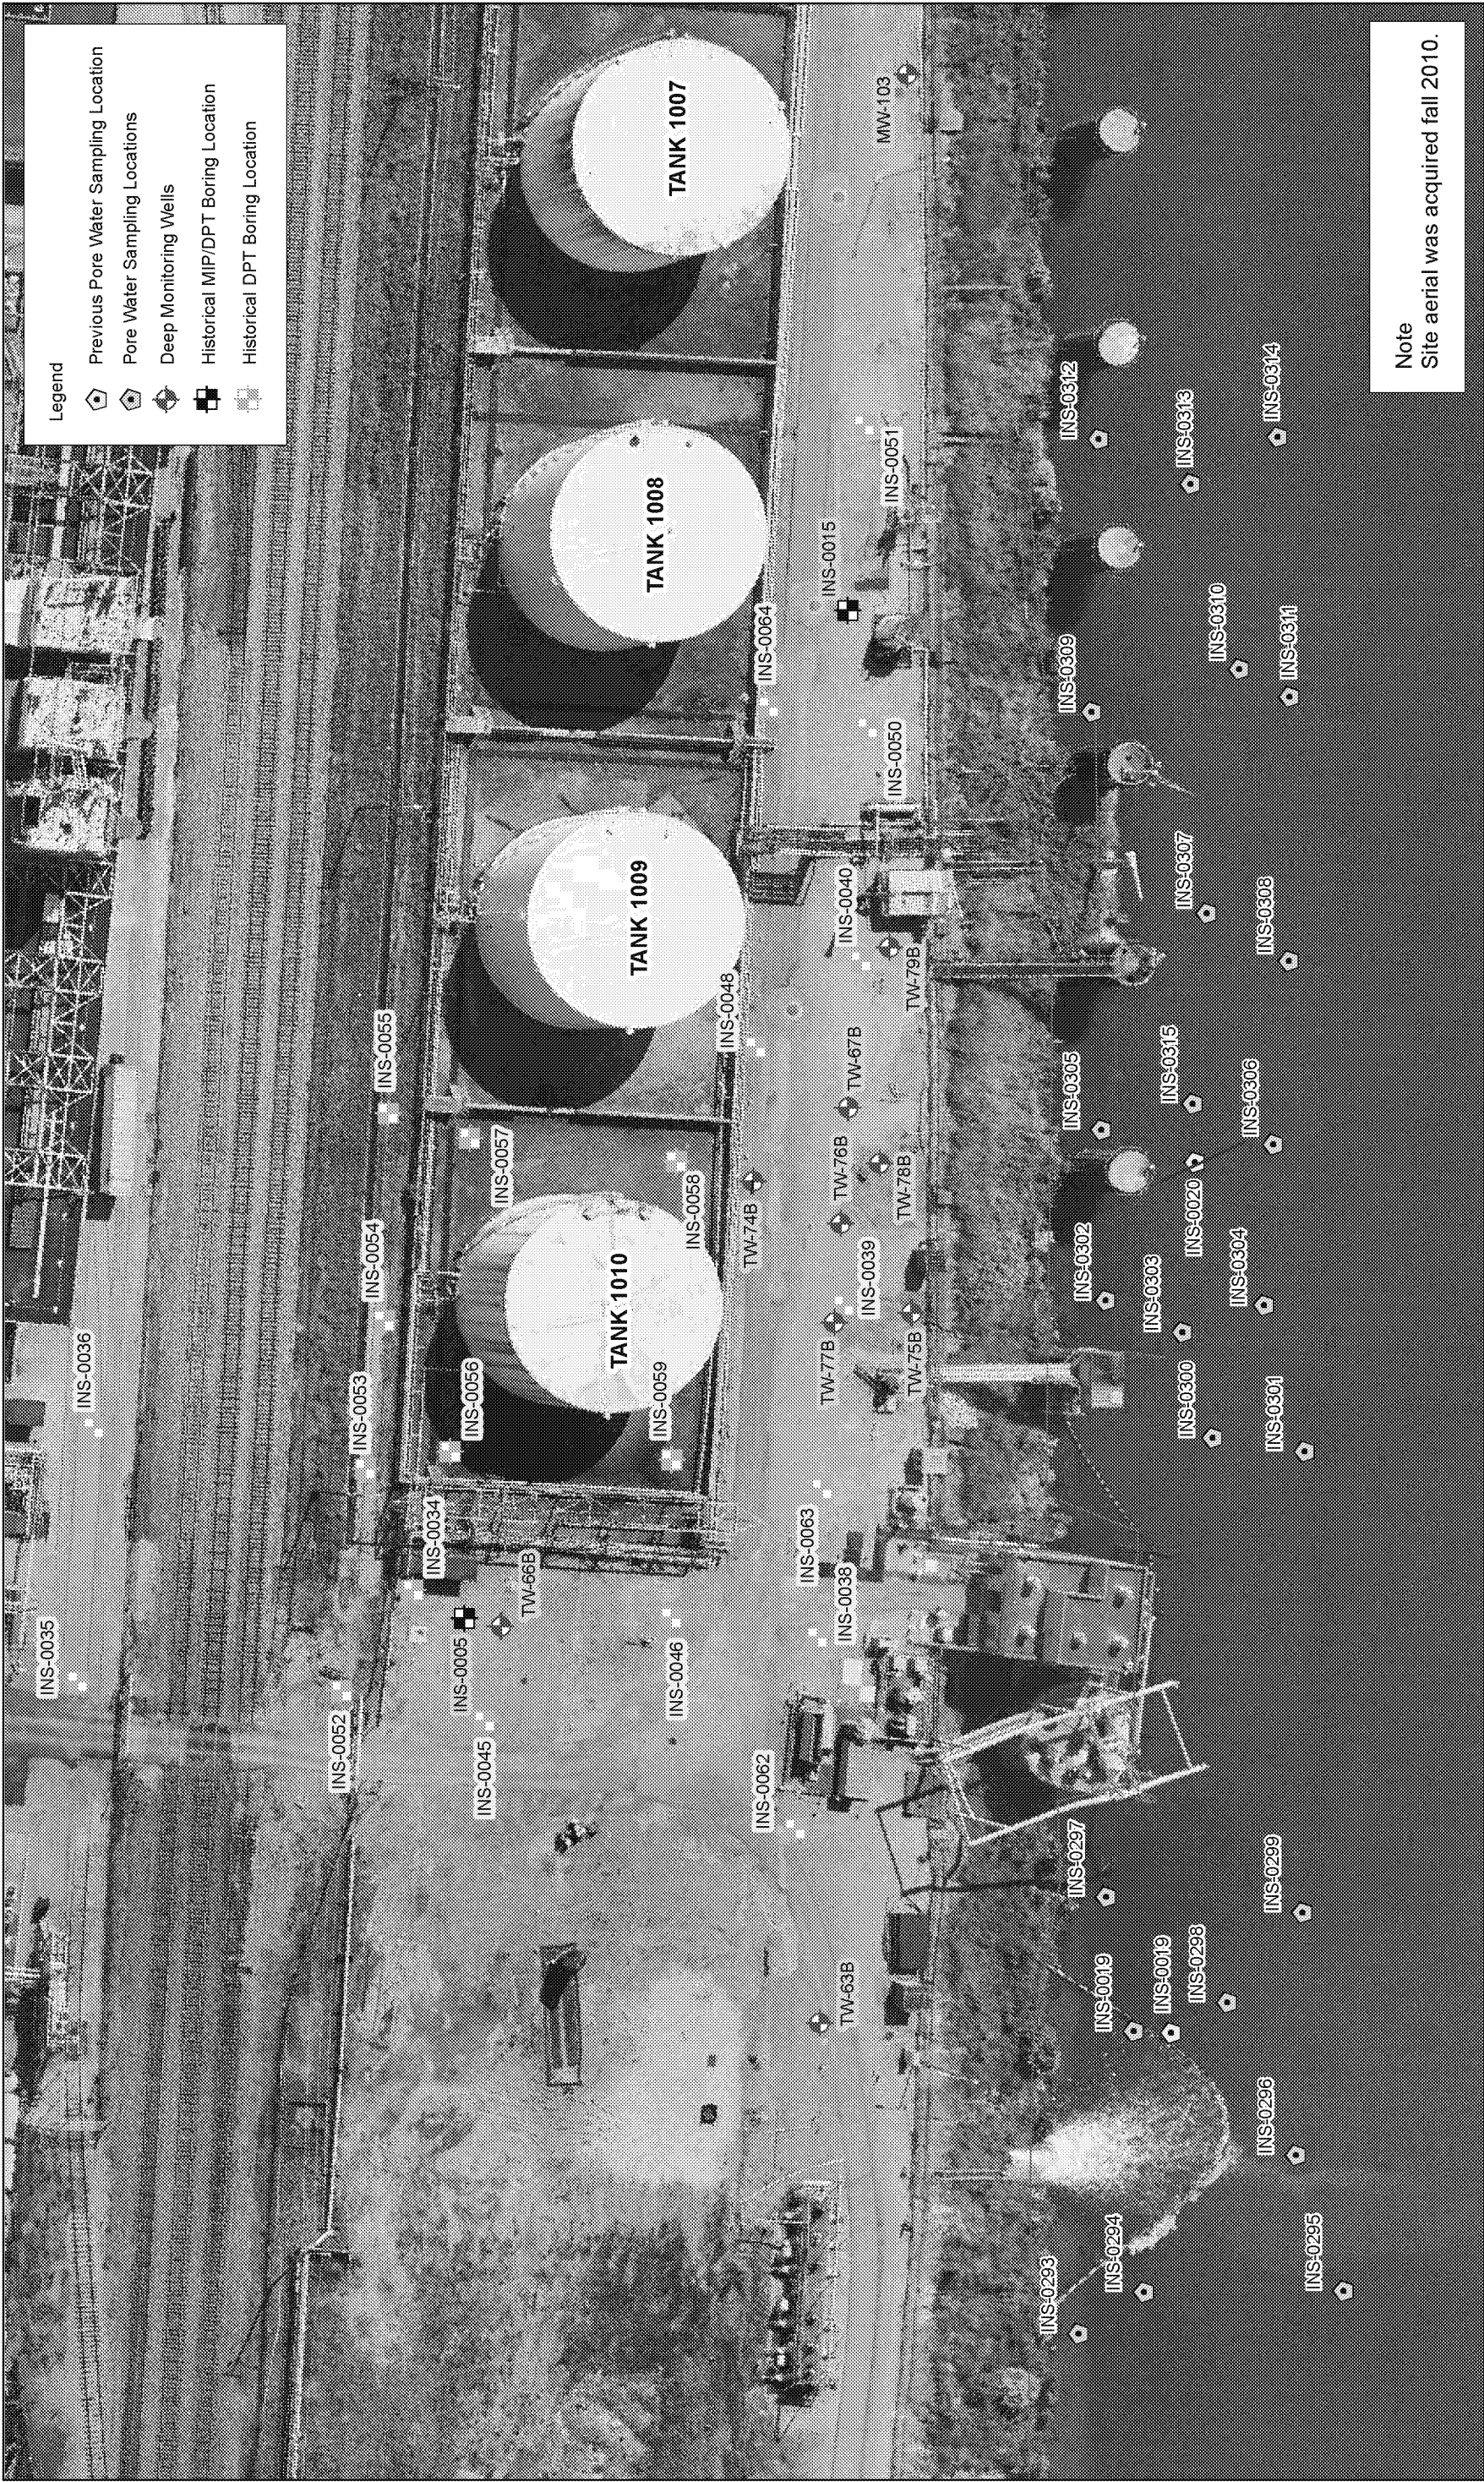
Figure 2-1
Pore Water Sampling Locations
HPD and Tank 1010 Pore Water Characterization Report
Bayer CropScience Institute Facility
Institute, West Virginia

Twenty-seven pore water locations were sampled over two sampling events. Twenty-six locations, shown on Figure 2-1, were sampled within the HPH and Tank 1010 areas. The other sample was collected approximately 800 feet downstream (not shown on figure). All samples were collected in accordance with the standard operating procedure (SOP) for the Trident probe (Appendix A). A Trident probe was used to collect the pore water samples from a boat in the Kanawha River. The Trident probe is a direct-push technology (DPT) system equipped with temperature, conductivity, and water sampling probes. Contrasts in temperature and conductivity between surface water and groundwater were used to determine if the locations sampled were representative of areas of venting groundwater. Onboard measurement of oxidation-reduction potential (ORP), pH, temperature, and conductivity differentials confirmed the samples were pore water and not surface water.

Pore water samples were collected from three locations adjacent to the facility (two in the HPH and Tank 1010 areas [Figure 2-1], and one additional location down river) to provide an indication of the concentration of VOCs in pore water beneath the Kanawha River adjacent to areas of known VOC-impacted groundwater at the facility.

Twenty-four samples were collected adjacent to the HPH Area (8 locations) and Tank 1010 Area (16 locations). Samples, for the most part, were collected in transects consisting of three locations: near shore, mid, and outer location (Figure 2-1). The locations within each transect are approximately 40 feet apart, and each transect is approximately 60 feet apart from one another.

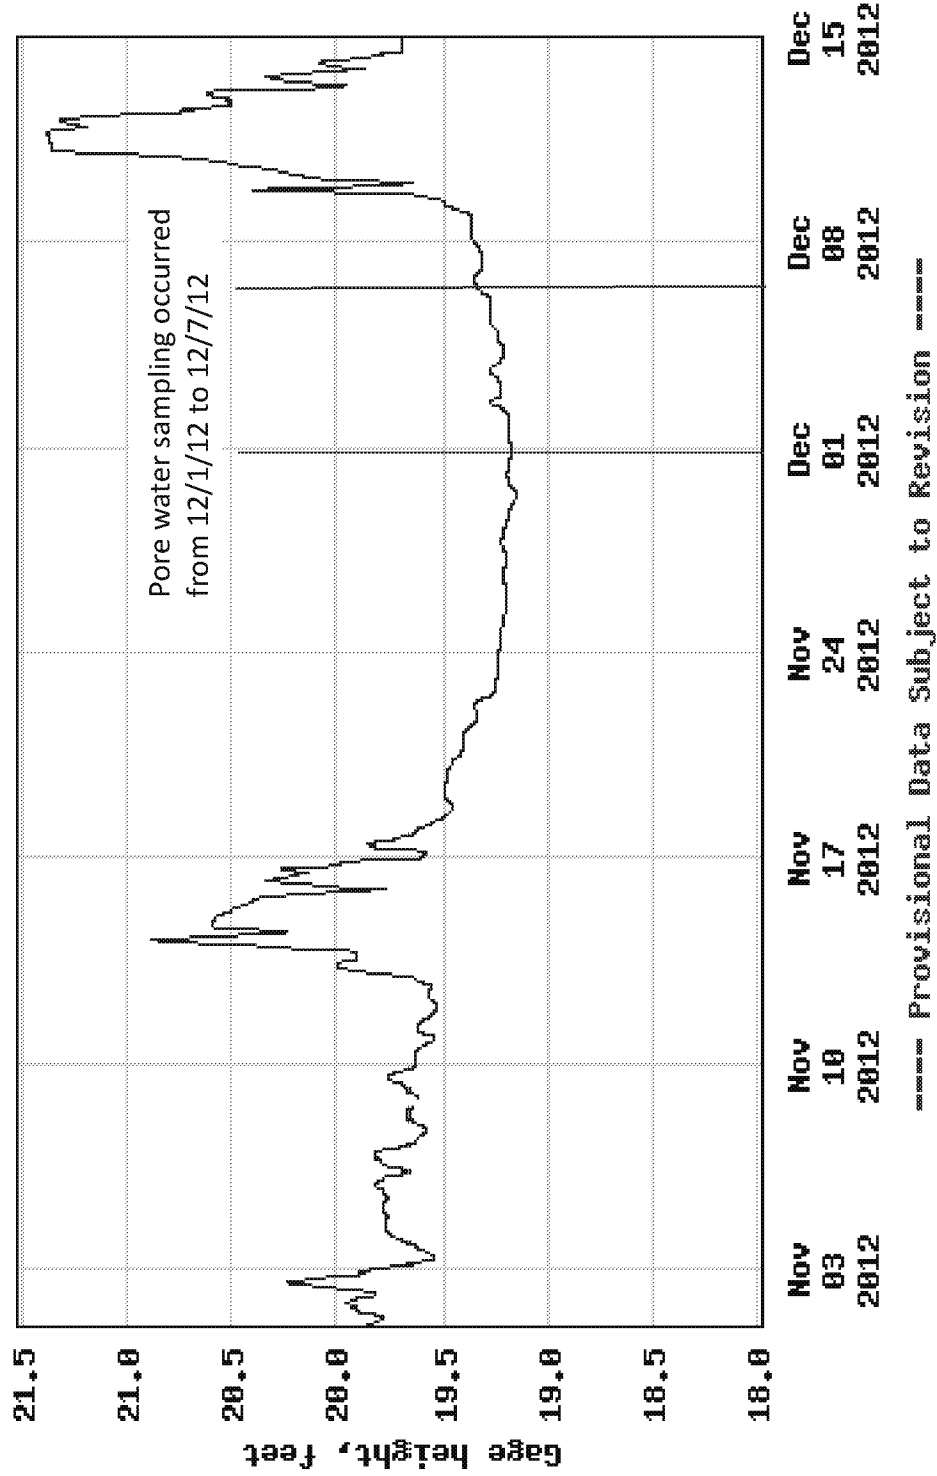
Figure 4-1

Note: Hydrograph obtained from USGS website. <http://waterdata.usgs.gov>

Kanawha River Gauge Hydrograph - 2012
 HPH and Tank 1010 Pore Water Characterization Report
 Bayer CropScience Institute Facility
 Institute, West Virginia

Water quality parameters were collected at each sampling location to verify the Trident probe was fully deployed into the sediment and pore water was being purged. The parameters are recorded in Table 4-1. The water quality parameters show a distinct differential between the surface water and pore water, indicating the samples collected were pore water. River stage data also were obtained from the U.S. Geological Survey website during the 2012 event to determine the samples were collected during optimal river conditions (Figures 4-1). The sampling event occurred when river levels were stable and between rain events.

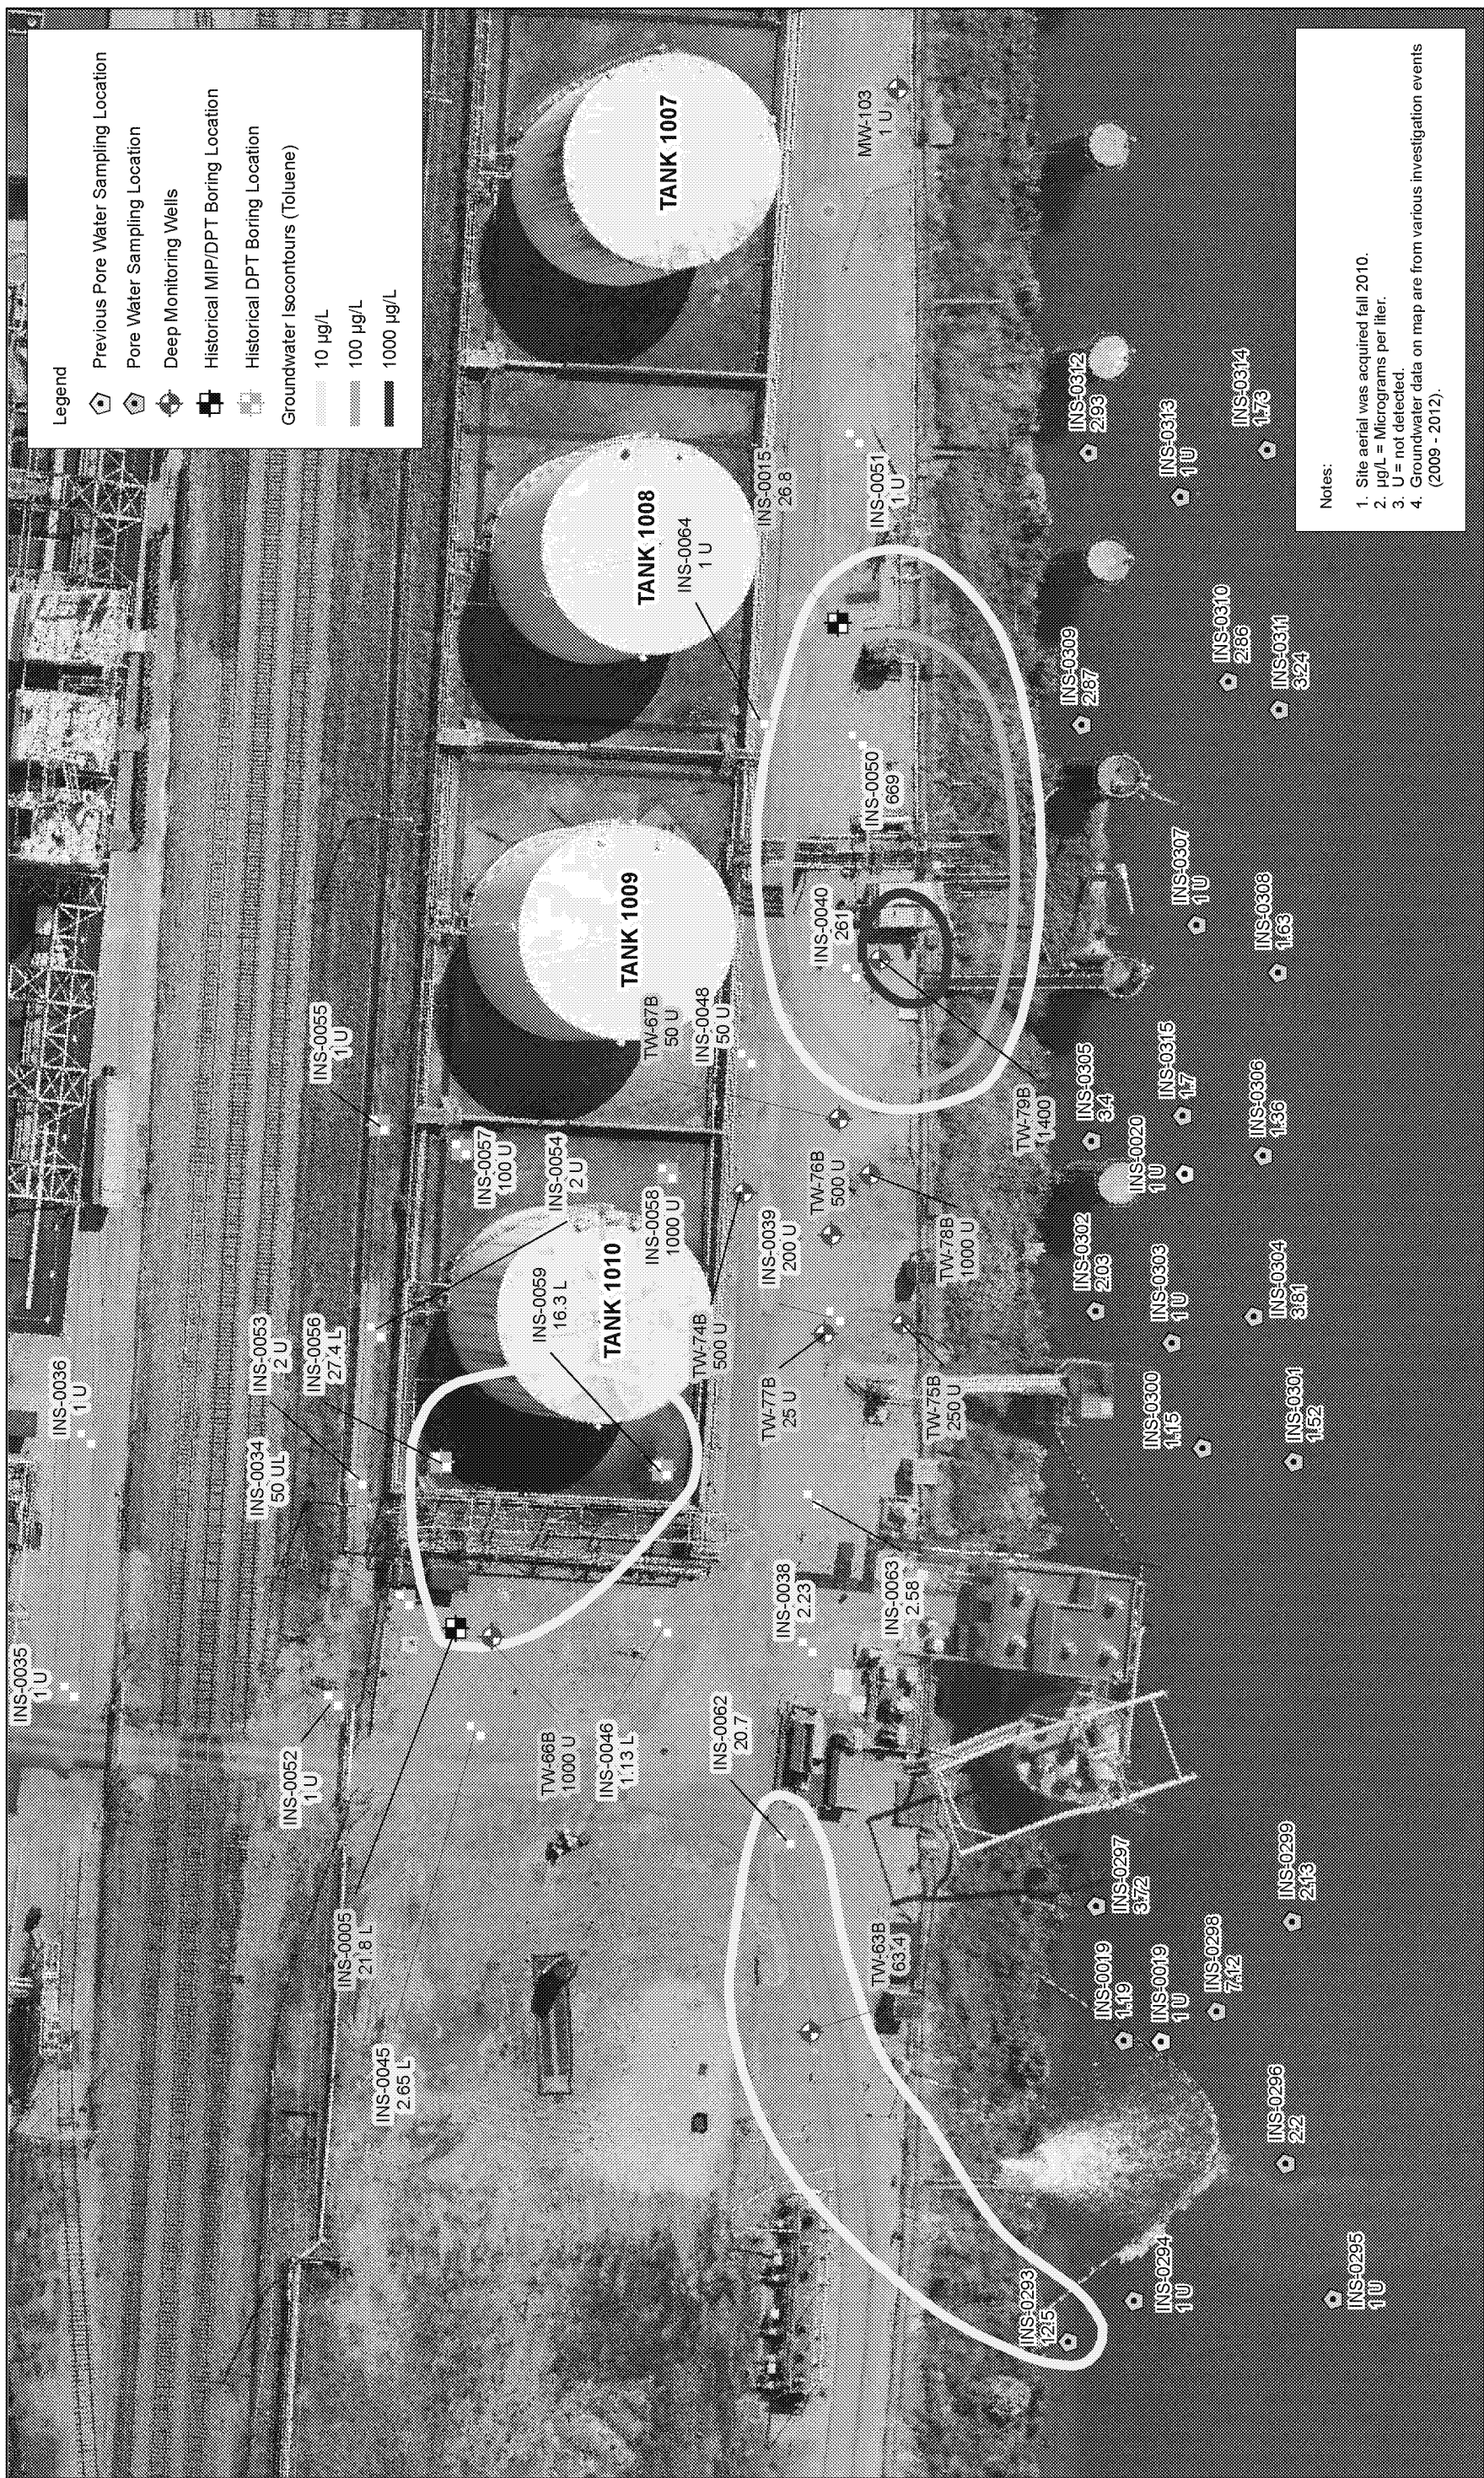
Toluene Isoconcentration Map - Deep Aquifer
HPH and Tank 1010 Pore Water Characterization Report
Bayer CropScience Institute Facility
Institute, West Virginia

Benzene and ethylbenzene were not detected in the pore water. Toluene was detected at 14 locations, and xylenes were detected at 11 locations. Figures 4-2, 4-3, 4-4, and 4-5 illustrate the 2012 groundwater plumes for toluene, benzene, ethylbenzene, and xylenes, respectively, along with the locations of the adjacent pore water samples.

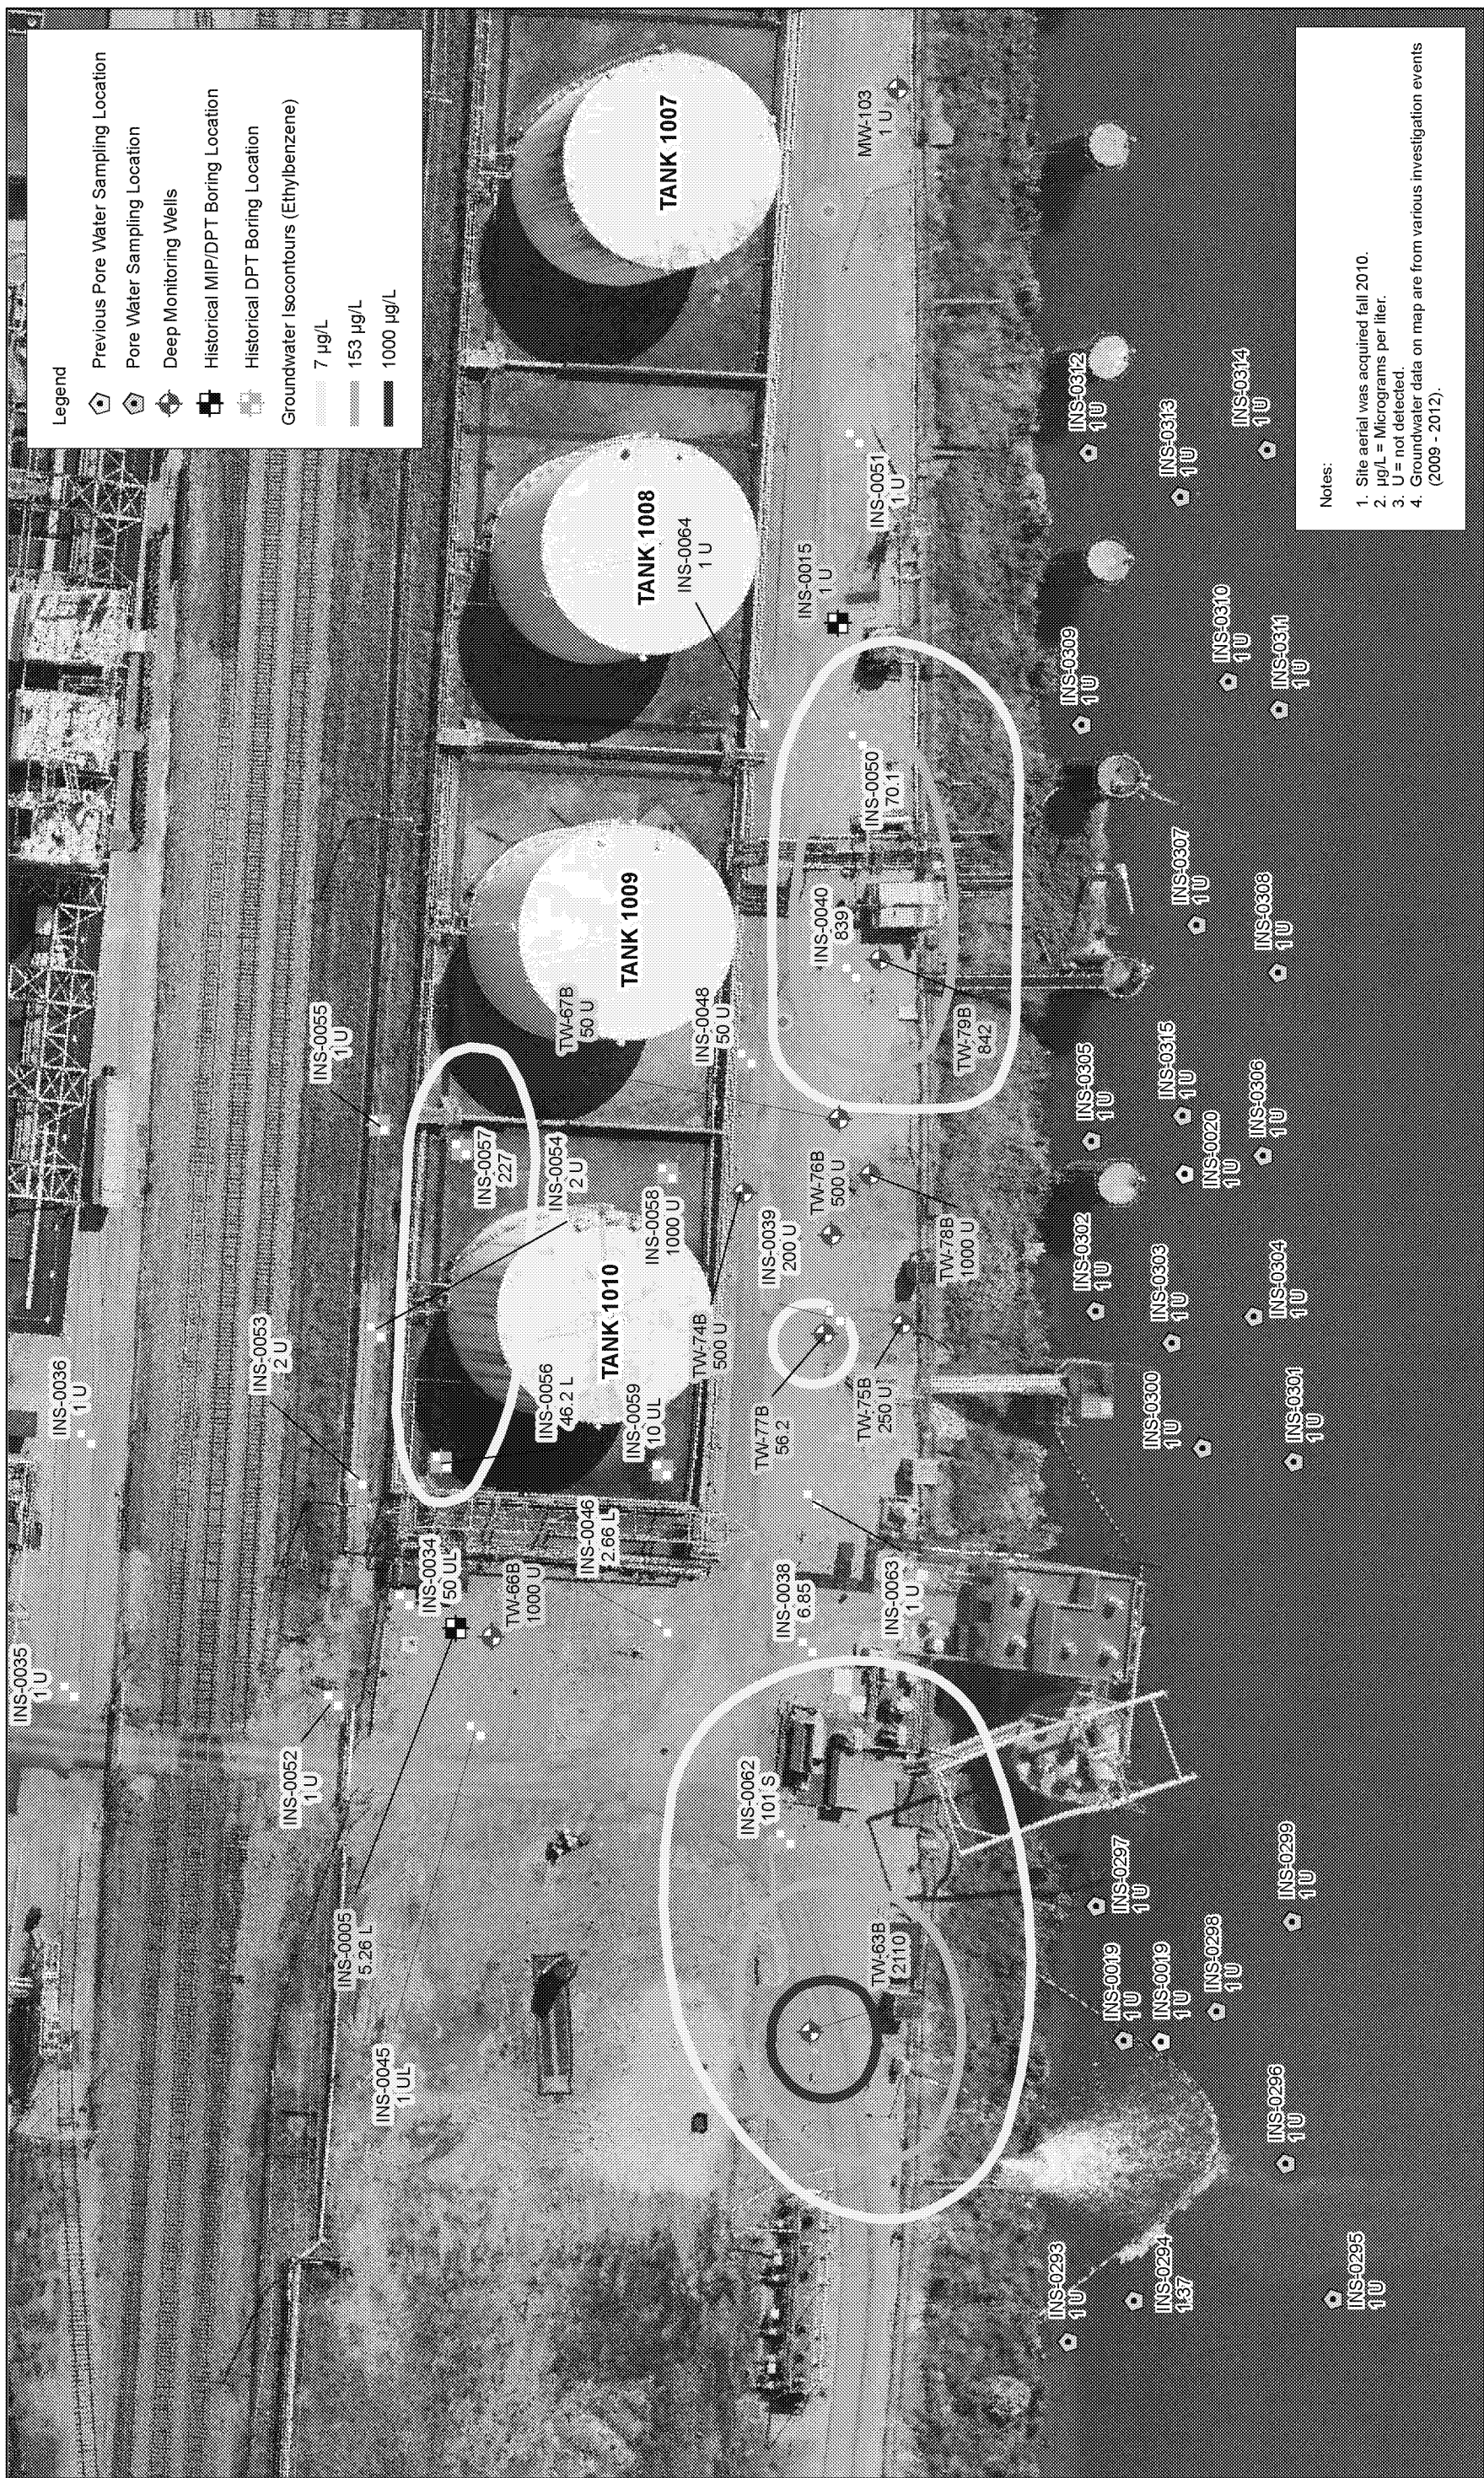
Ethylbenzene Isoconcentration Map - Deep Aquifer
HPH and Tank 1010 Pore Water Characterization Report
Bayer CropScience Institute Facility
Institute, West Virginia

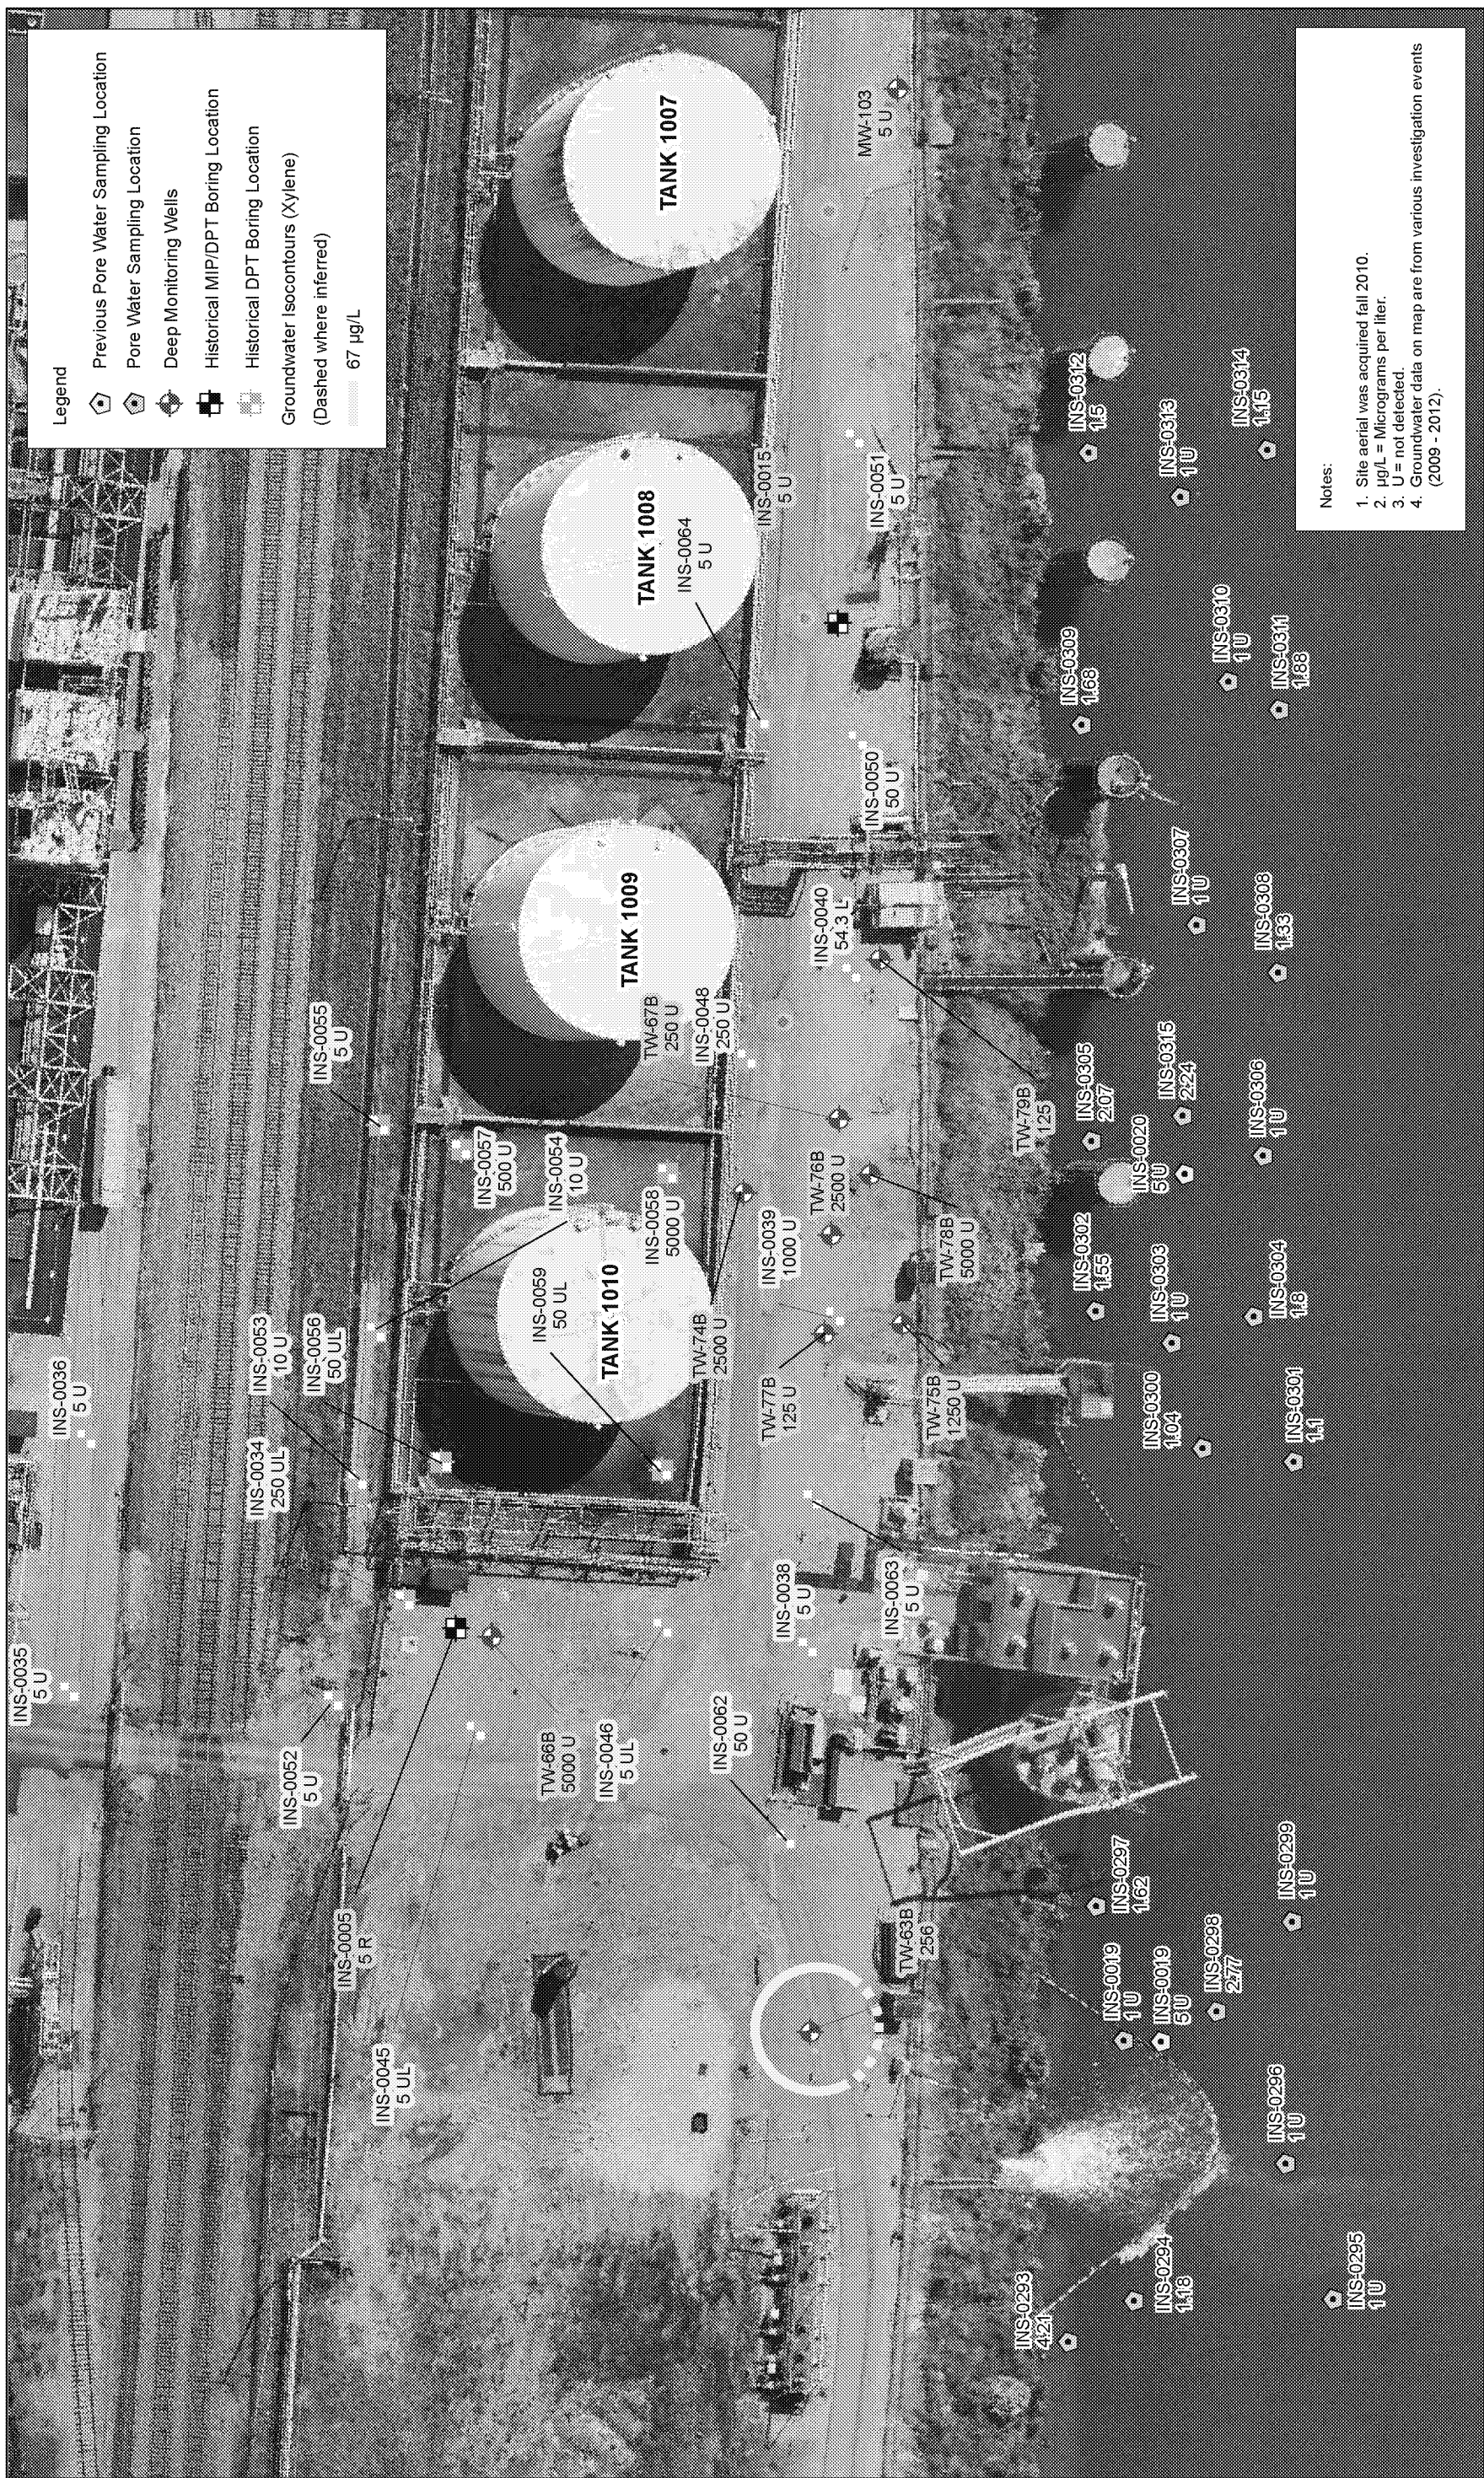
Total Xylenes Isoconcentration Map - Deep Aquifer
HPH and Tank 1010 Pore Water Characterization Report
Bayer CropScience Institute Facility
Institute, West Virginia

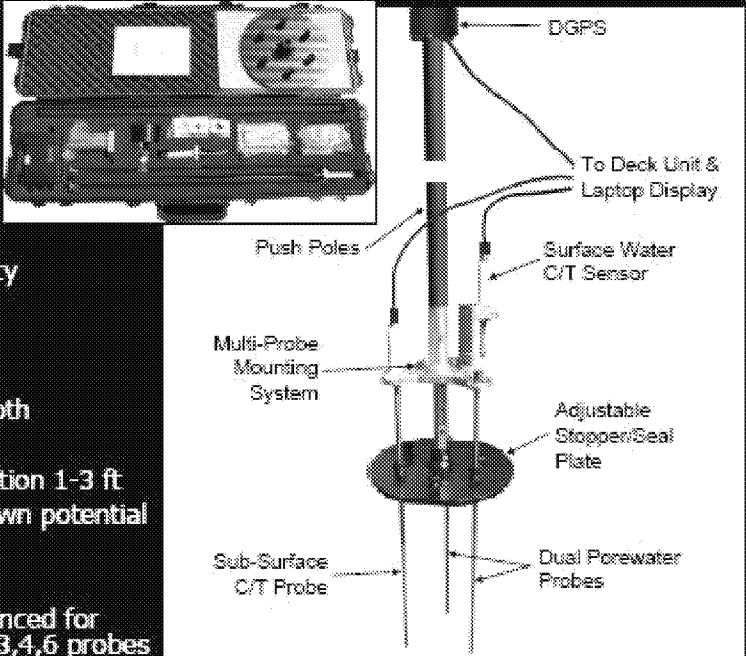
- **C/T Sensors:**
 - Surface water
 - Subsurface
- **Porewater Sampler:**
 - Screen point
 - Dual probe
- **Integrated GPS**
 - Differential accuracy
 - GIS display
- **Push pole system:**
 - 6 ft sections
 - 0 – 50 ft water depth
- **Stopper Plate:**
 - Adjustable penetration 1-3 ft
 - Minimizes draw down potential
- **Mounting System**
 - Up to 6 probes
 - Symmetrically balanced for combinations of 2,3,4,6 probes

The diagram illustrates the Trident Probe System components and their assembly. On the left, a photograph shows the system's electronics, including a GPS unit with a screen and a control panel with buttons and a dial. On the right, a schematic diagram shows the vertical assembly of the probe system. Labels with leader lines identify the following parts: DGPS (Differential GPS) at the top; To Deck Unit & Laptop Display connected to the main unit; Push Poles forming the vertical structure; Multi-Probe Mounting System in the middle; Adjustable Stopper/Seal Plate near the bottom; Sub-Surface C/T Probe (Conductivity/Temperature) at the very bottom; and Dual Porewater Probes branching from the side near the stopper plate. A Surface Water C/T Sensor is also shown near the top of the push poles.

The Trident probe is a direct-push, integrated temperature sensor, conductivity sensor, and pore water sampler developed to screen sites for areas where groundwater may be discharging to a surface water body (Chadwick et al. 2003). Differences in observed conductivity and temperature indicate areas where groundwater discharge is occurring. The integral pore water sampler can be used to rapidly confirm the presence of freshwater or other chemical constituents. The primary tasks include the following:
